Environmental Abatement and Building Demolition (Scope of Work) Request for Proposal (RFP)

**Former WBE Hotel
100 Westbank Expressway
Gretna, LA 70053**

**LDEQ Agency Interest No.: 243583
Previous AI#s 211773 & 138932**

**September 2024
Leaaf # COG-053C**

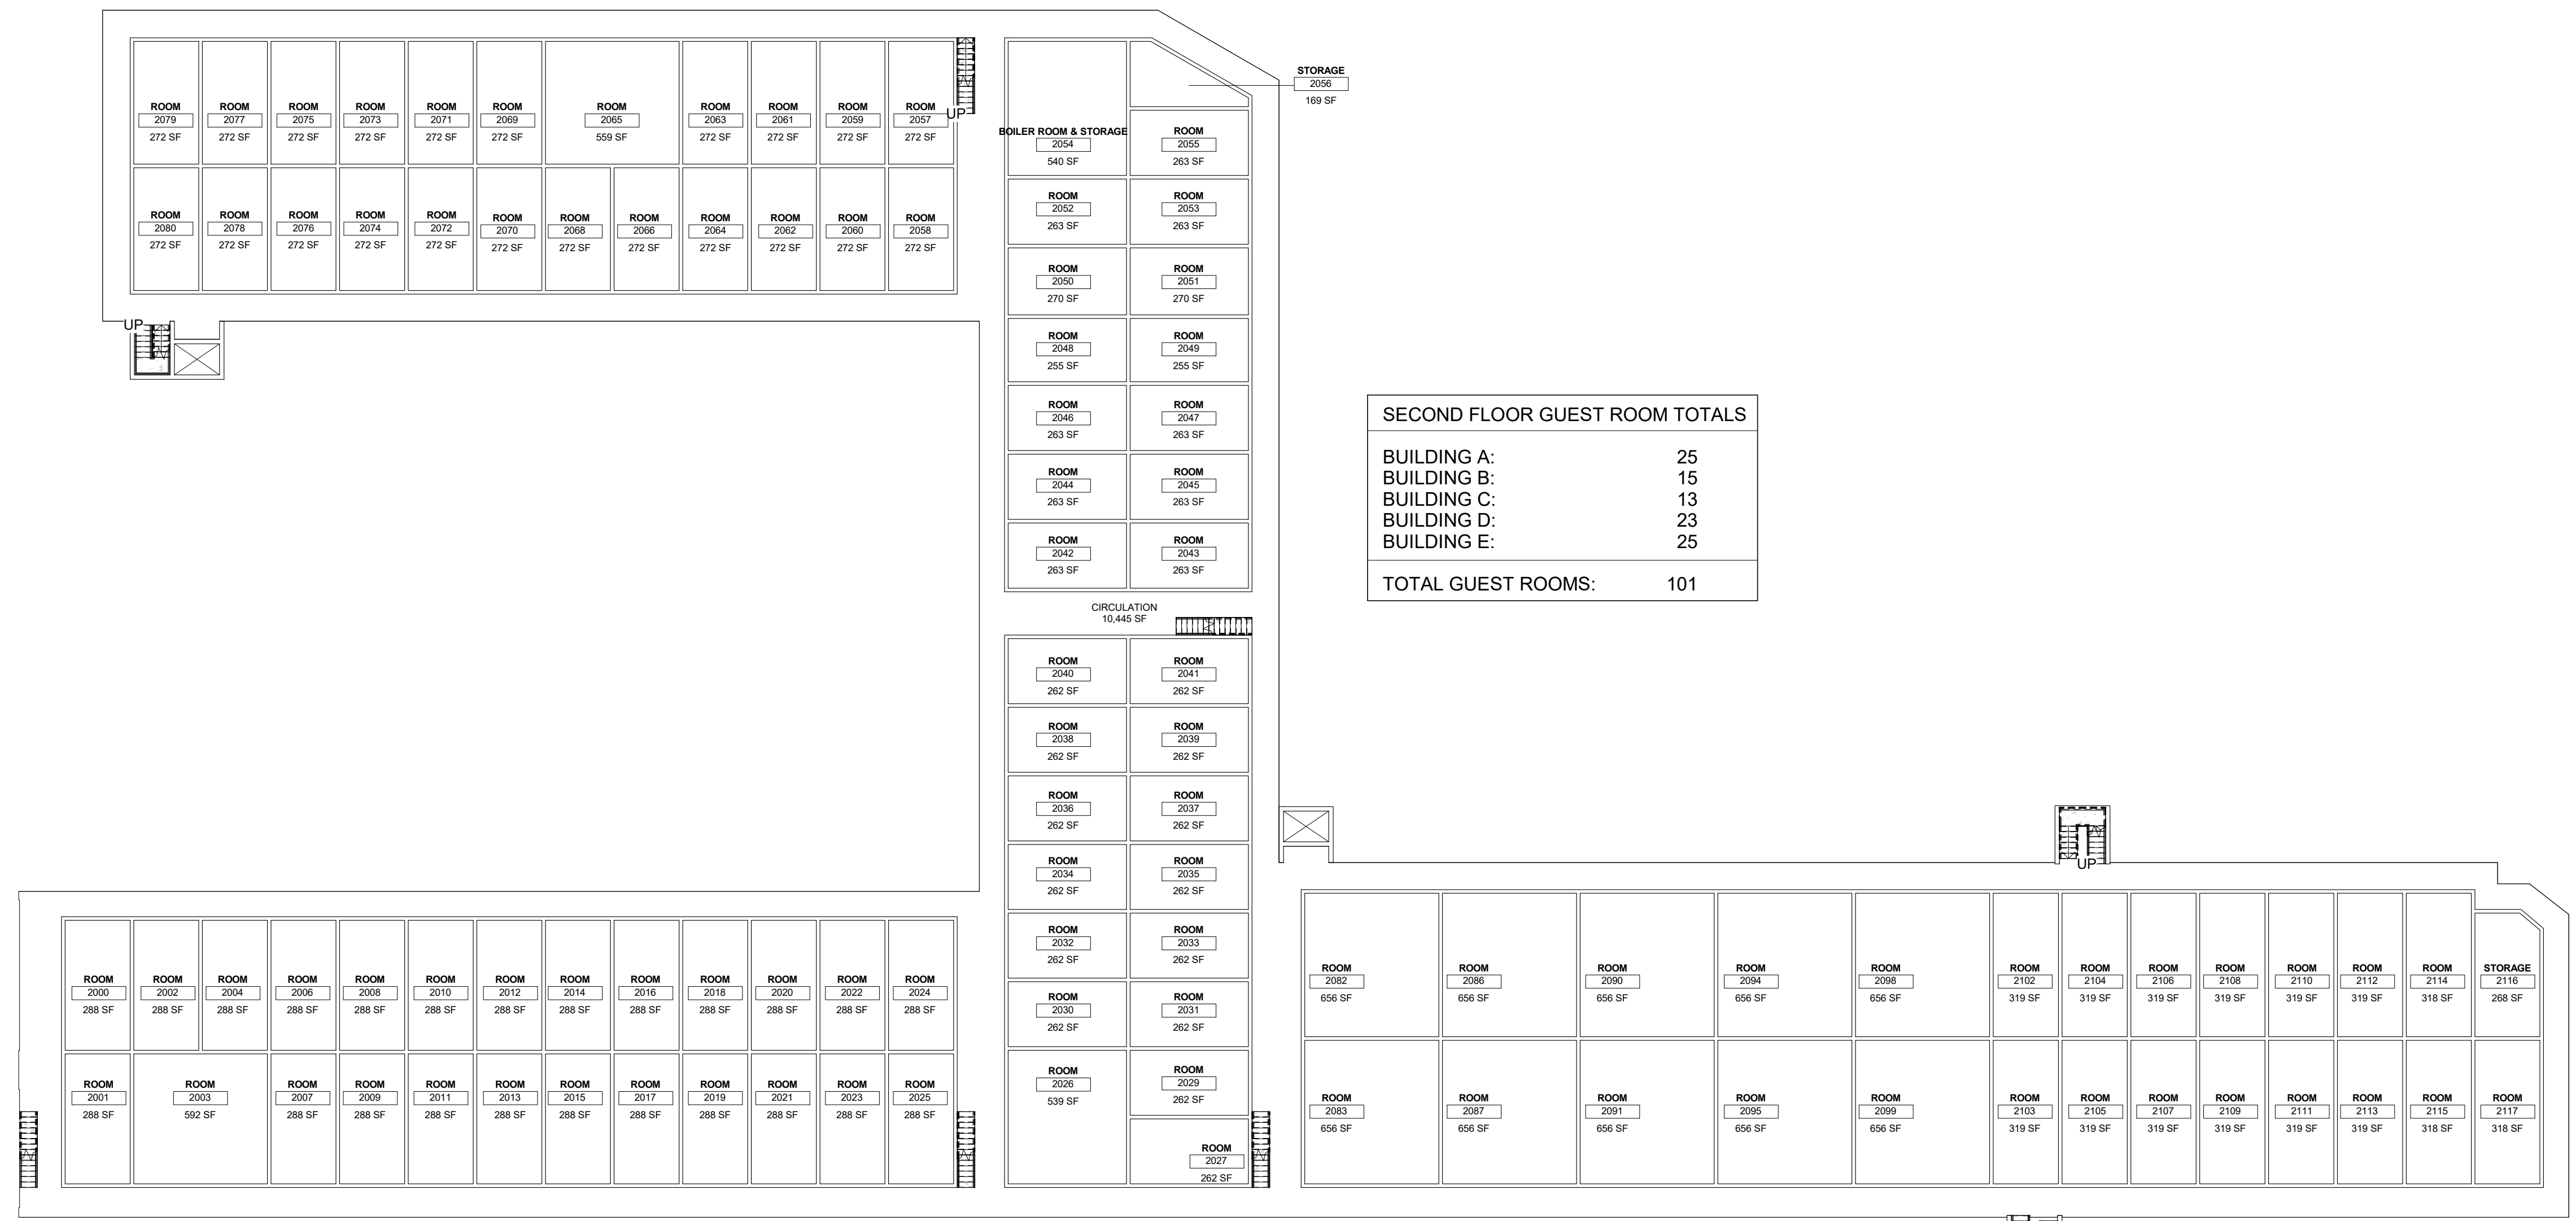
**BUILDING D:
GUEST ROOMS = 23
7,226 SF**

**BUILDING C:
GUEST ROOMS = 13
4573 SF**

SECOND FLOOR GUEST ROOM TOTALS

BUILDING A:	25
BUILDING B:	15
BUILDING C:	13
BUILDING D:	23
BUILDING E:	25
TOTAL GUEST ROOMS:	101

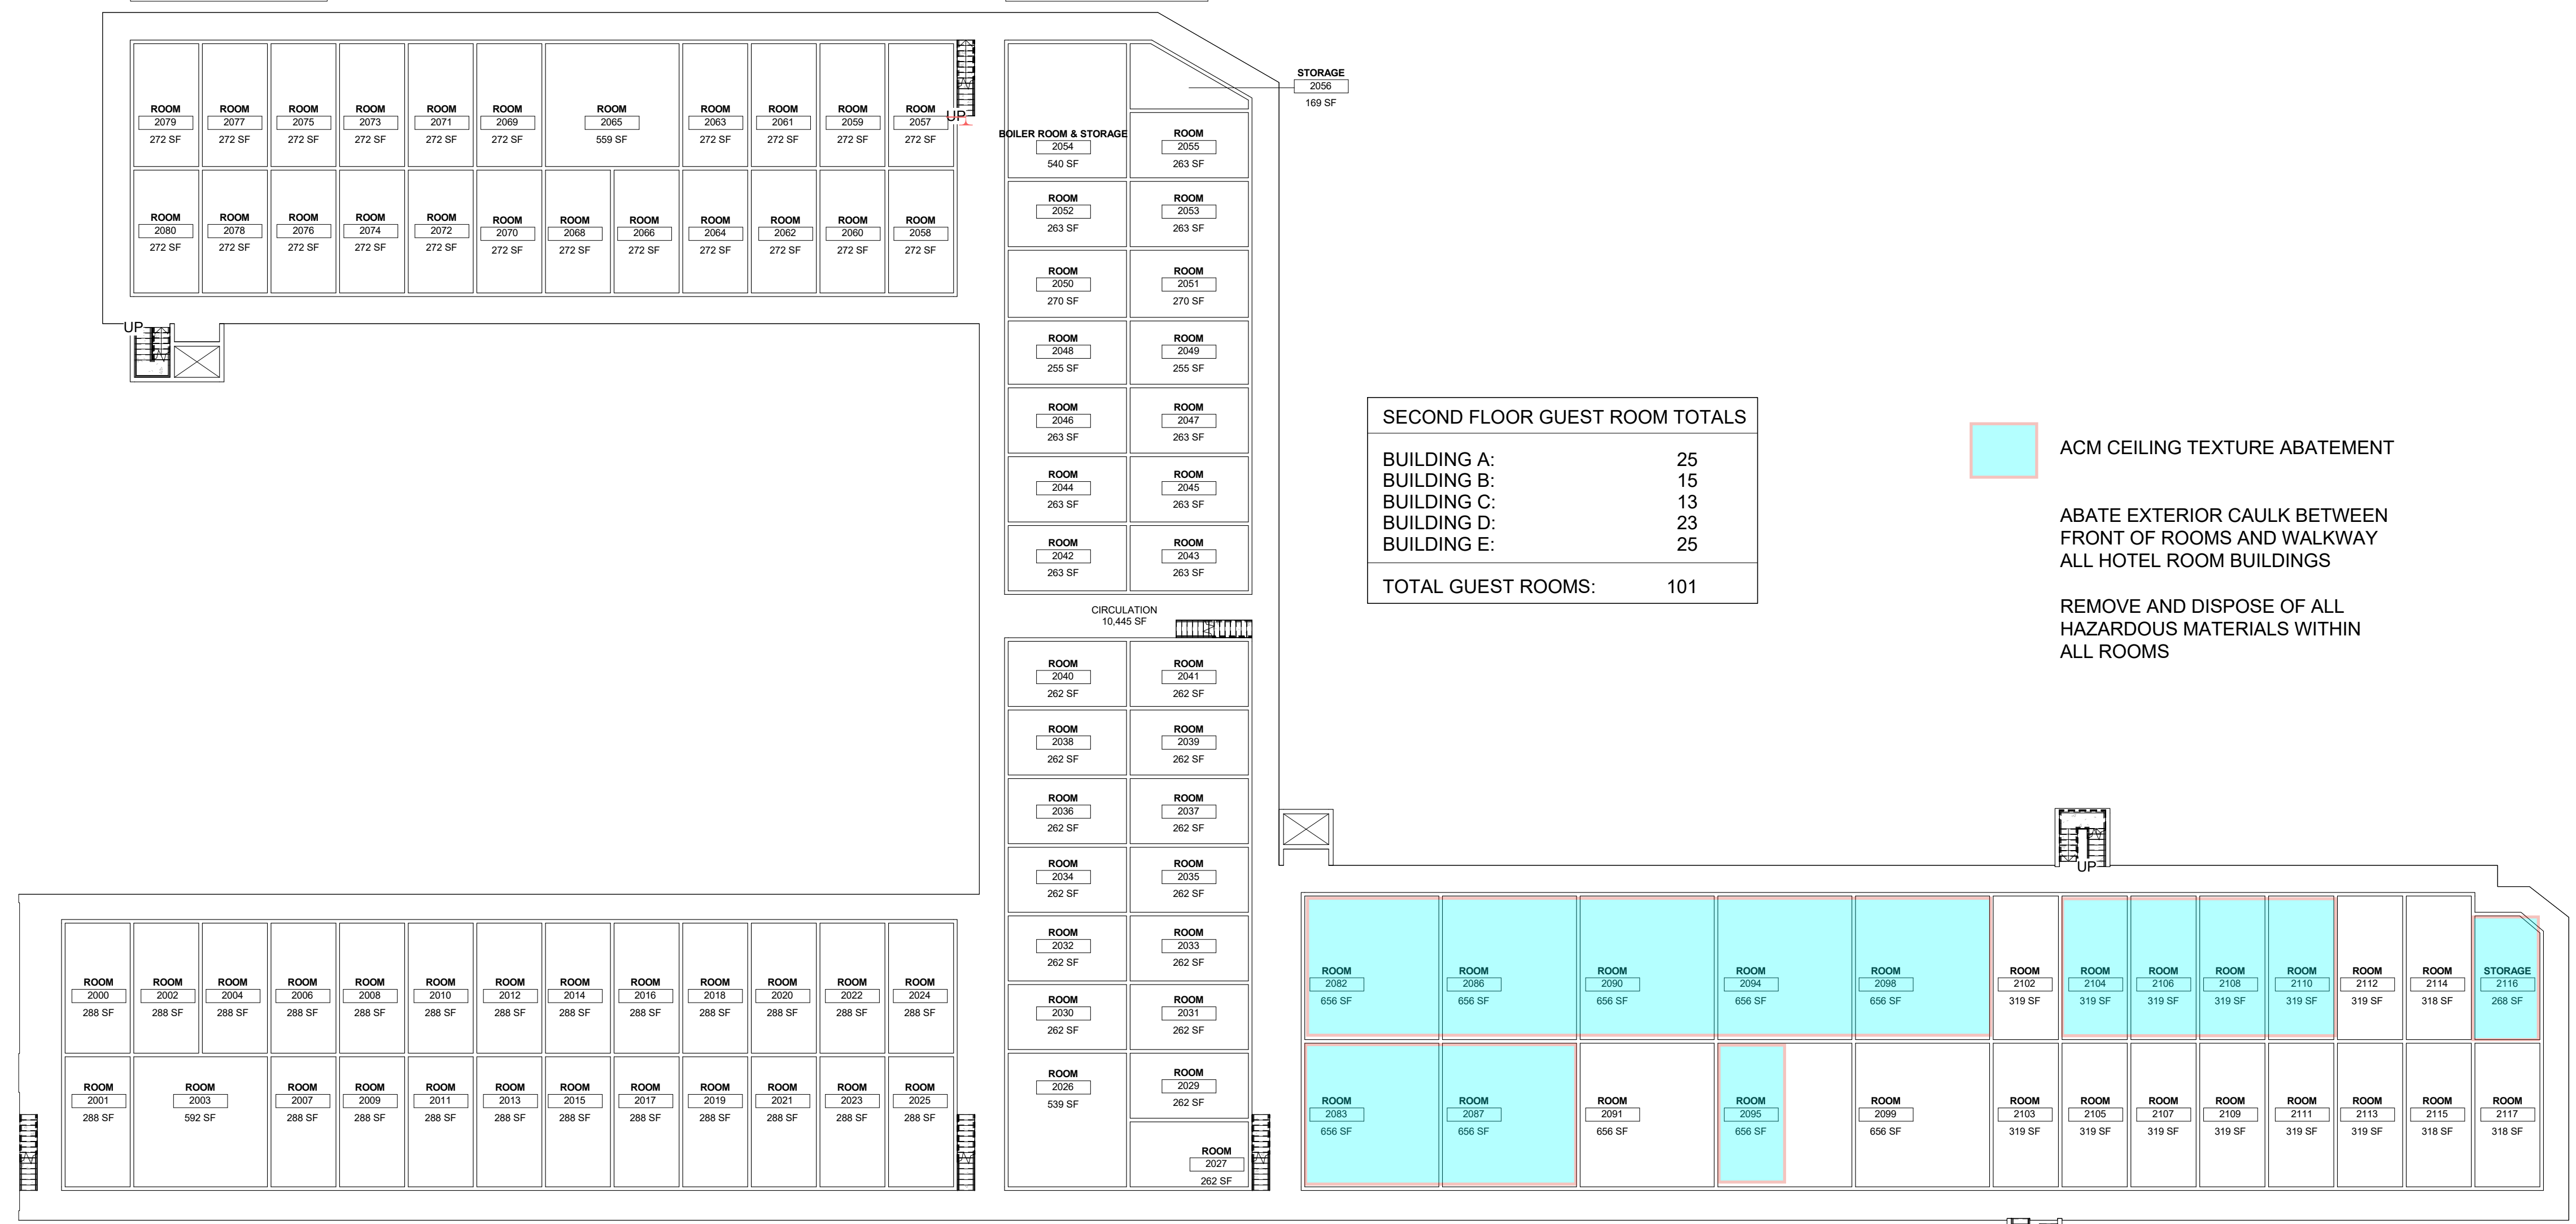
**BUILDING D:
GUEST ROOMS =23
7,226 SF**

**BUILDING C:
GUEST ROOMS = 13
4573 SF**

SECOND FLOOR GUEST ROOM TOTALS

BUILDING A:	25
BUILDING B:	15
BUILDING C:	13
BUILDING D:	23
BUILDING E:	25
TOTAL GUEST ROOMS:	101

- NOTES:
1. Set up Containment as needed to perform ACM abatement.
 2. Provide electrical and water utilities to complete abatement.
 3. Do not put any asbestos or hazardous materials down sanitary sewerage system.
 4. Submit AAC-2 Forms to obtain ADVFs
 5. Complete environmental scope per building and obtain written clearance prior to any demolition activities.
 6. Secure Site with temporary fencing in areas where fencing does not surround Site.
 7. Remove and properly dispose/recycle of all hazardous materials at appropriate landfill/recycling facility prior to demolition.

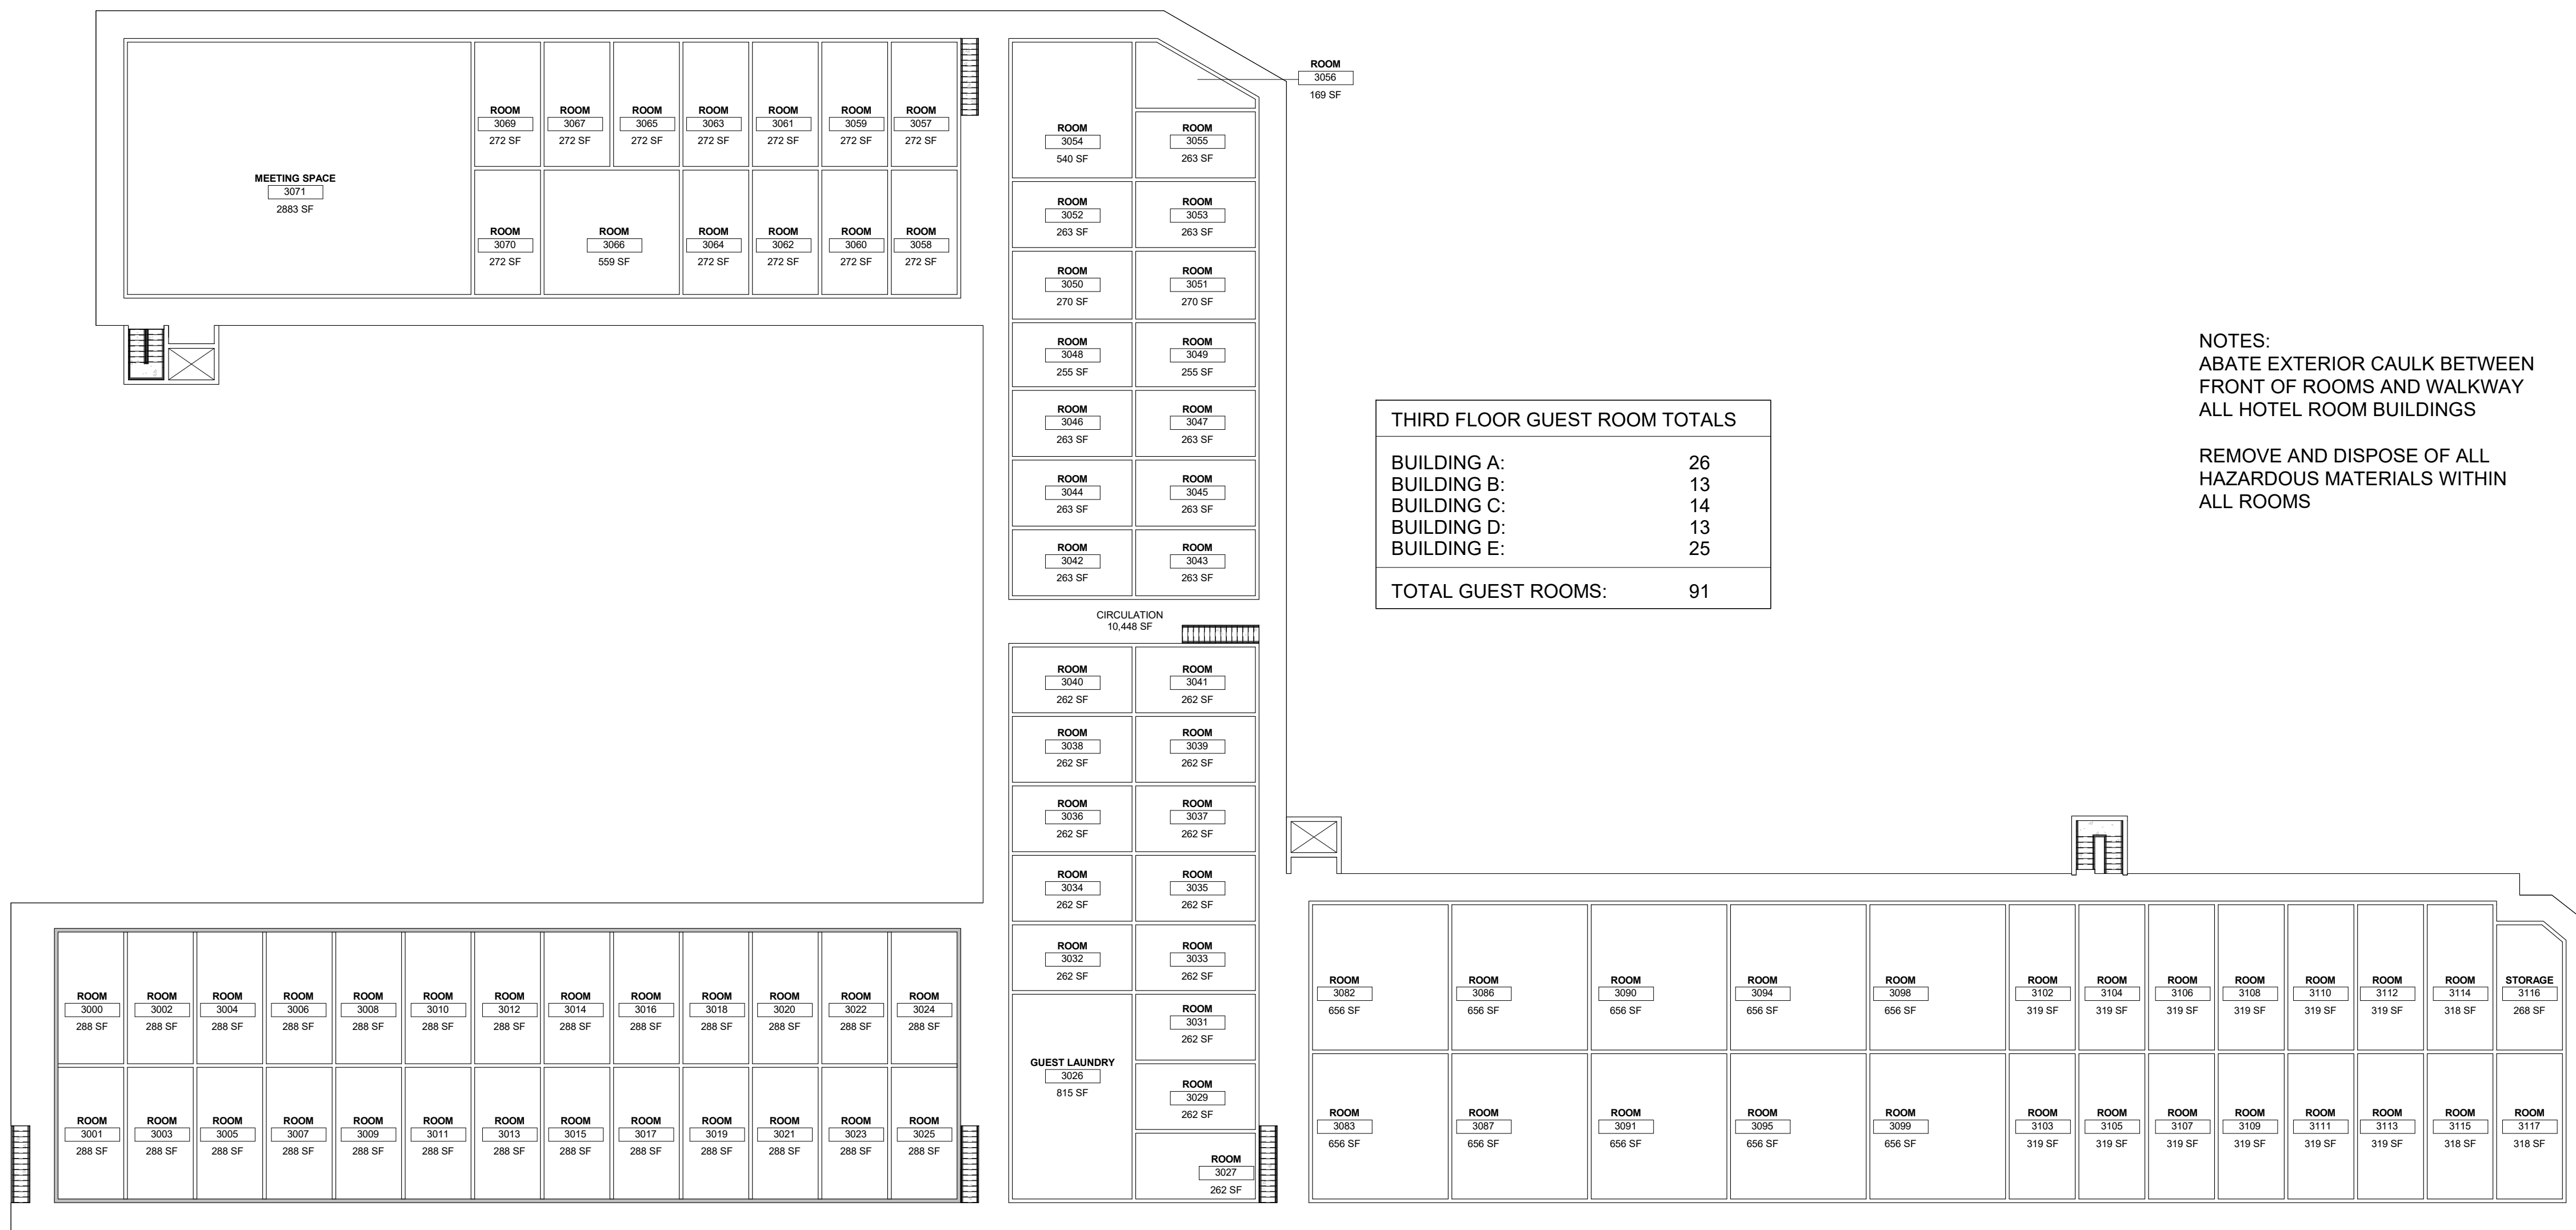
NOTES:
ABATE EXTERIOR CAULK BETWEEN
FRONT OF ROOMS AND WALKWAY
ALL HOTEL ROOM BUILDINGS
